# STORMWATER FACILITIES MAINTENANCE & MITIGATION

PRESENTED BY: DILLON FATOUROS, ASSISTANT SECRETARY

ANNUAL HOA MEETING – APRIL 8, 2025

West Winds Master Homeowners' Association, Inc.

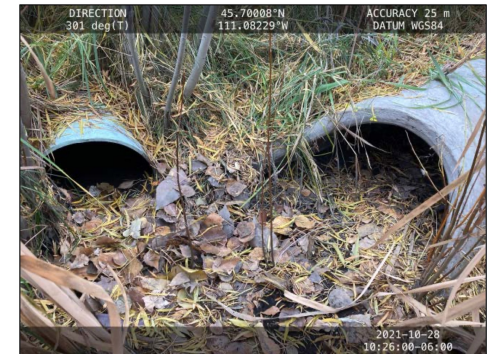
Image 2  
Inlets at west end of detention facility, partially clogged with sediment

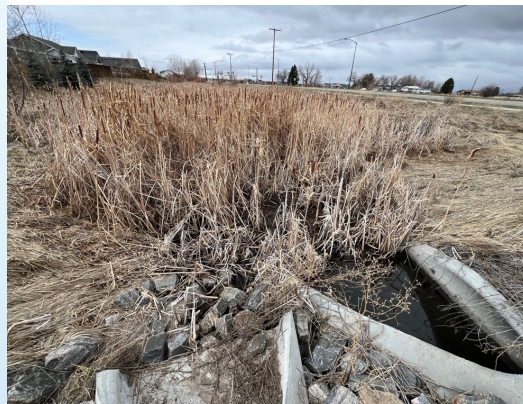
Image 3  
Detention Facility outlet; inhibited flow and vegetation growth.

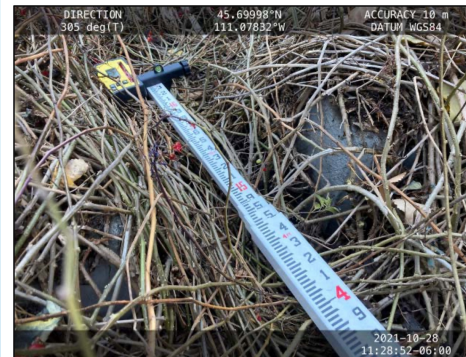
Image 3  
Severe overgrowth at slotted concrete weir, near detention facility outlet

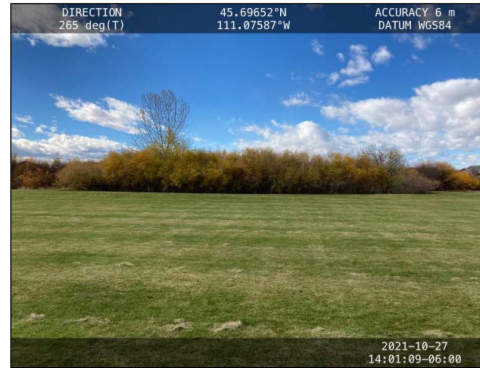
Image 1  
Detention Facility 2A Overview – note abundance of willow

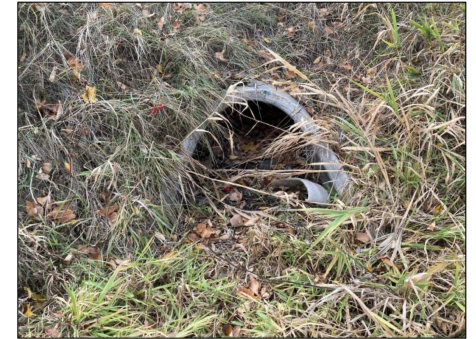
Image 2  
Detention Facility Inlet showing sediment accumulation

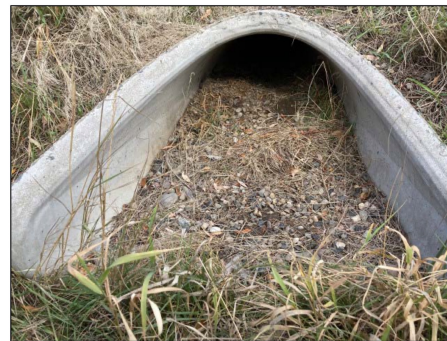
Image 3  
Detention Facility Outlet showing sediment accumulation

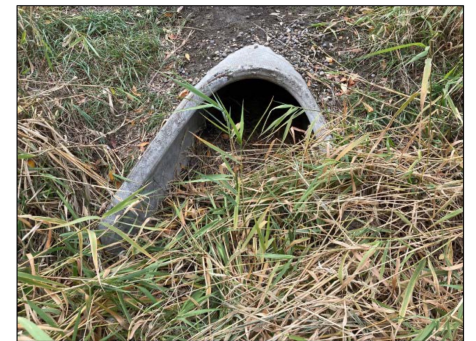
Image 4  
Detention Facility Outfall with vegetation and sediment accumulation

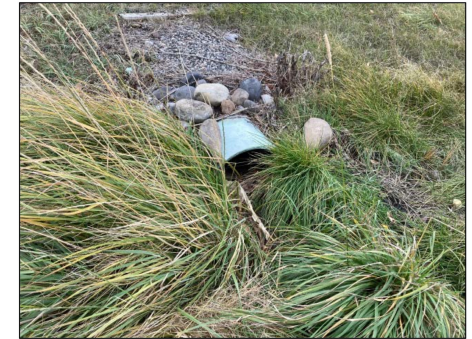
Image 2  
Overgrown grass at facility inlet

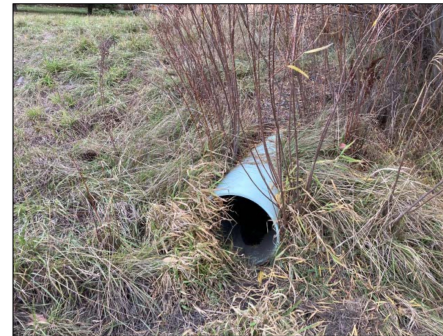
Image 3  
Outlet pipe within detention facility showing willow growth encroachment

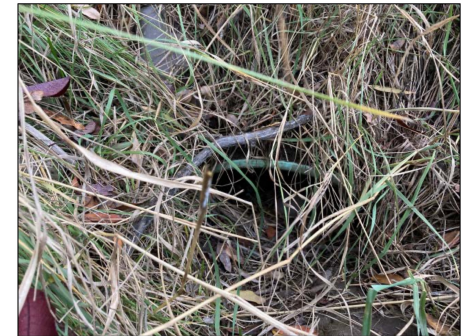
Image 4  
Vegetation growth at facility outfall

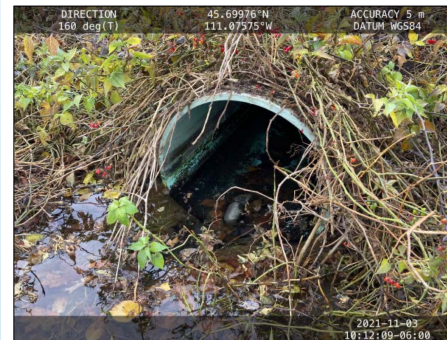
Image 3  
Southern detention facility inlet, water flowing into basin from around and outside of pipe

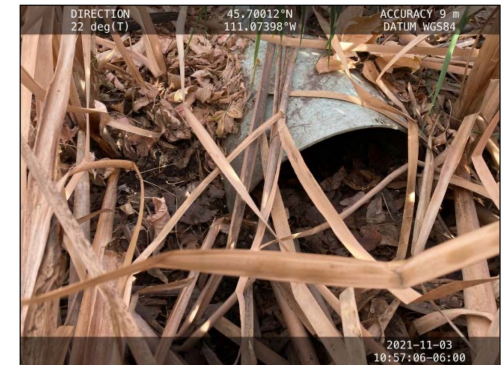
**Findings and Recommended Actions:** Significant overgrowth of cattails has constricted stormwater storage volume and there is a high risk of conveyance plugging at the pipe flowing in to the facility. Retention ponds do not have an active, piped outlet and wholly rely on infiltration. Sediment and excessive vegetation should be removed to improve infiltration.

Image 2  
Retention Facility inlet from Baxter Ln; more than 1/2 filled with sediment
