Subject: West Winds Stormwater Facility Management.
Date: Friday, July 28, 2023 at 1:46:51 PM Mountain Daylight Time
From: Russell Smith <rsmith@BOZEMAN.NET>
To: Debbie Chard <Debbie.Chard@westwindshoabozeman.org>, David Gianforte <David.Gianforte@westwindshoabozeman.org>, Kitch Walker <Kitch.Walker@westwindshoabozeman.org>
CC: Contact West Winds HOA <contact@westwindshoabozeman.org>
Attachments: Annual_Stormwater_Facility_SelfInspection_FillableForm.pdf, Stormwater Facility Maintenance Guide Sept2021.pdf, Pond Managment Guide EPA.pdf, West Winds Stormwater Inspection Report.pdf, West Winds Report CovLet.pdf, West Winds Stormwater Facilities Map.pdf, ATT00001.txt, ATT00002.htm

RE: West Winds HOA Stormwater Infrastructure Inspection

Stormwater Facilities Inspection Report

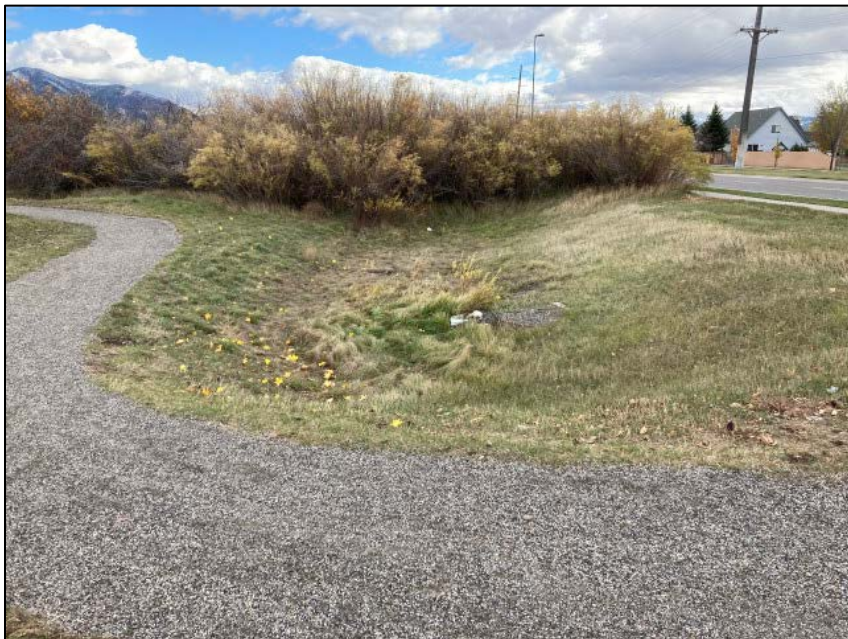
Image 1
Detention facility overview looking east

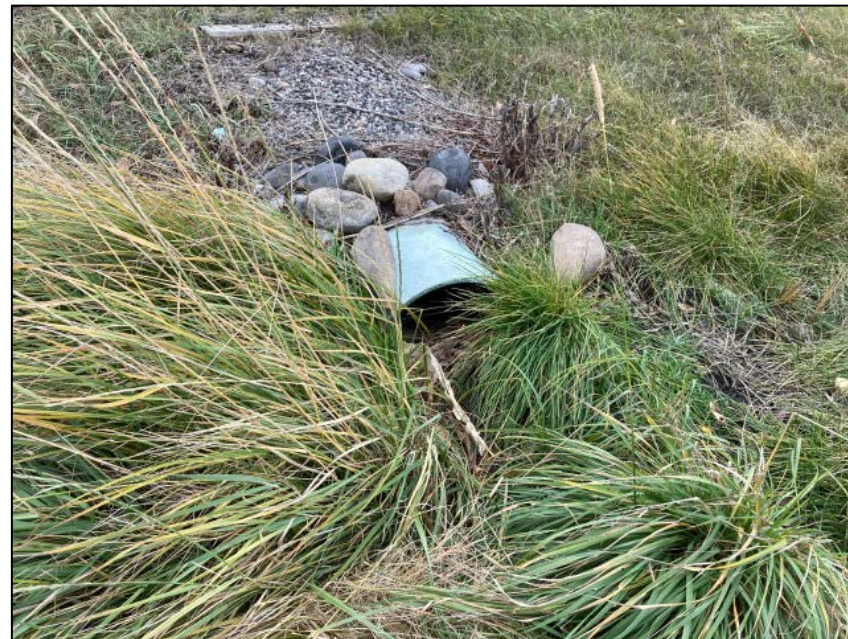
Image 2
Overgrown grass at facility inlet

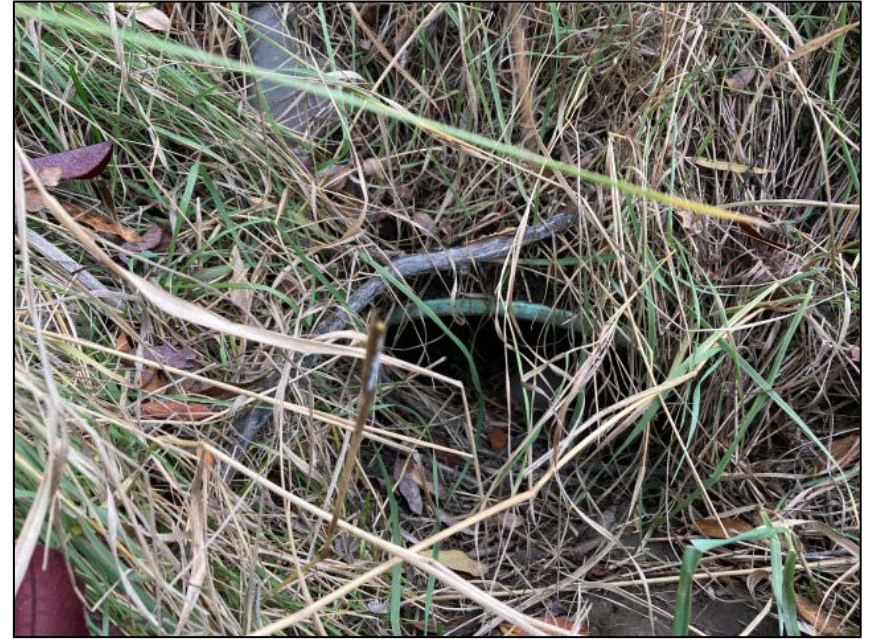
Image 4
Vegetation growth at facility outfall

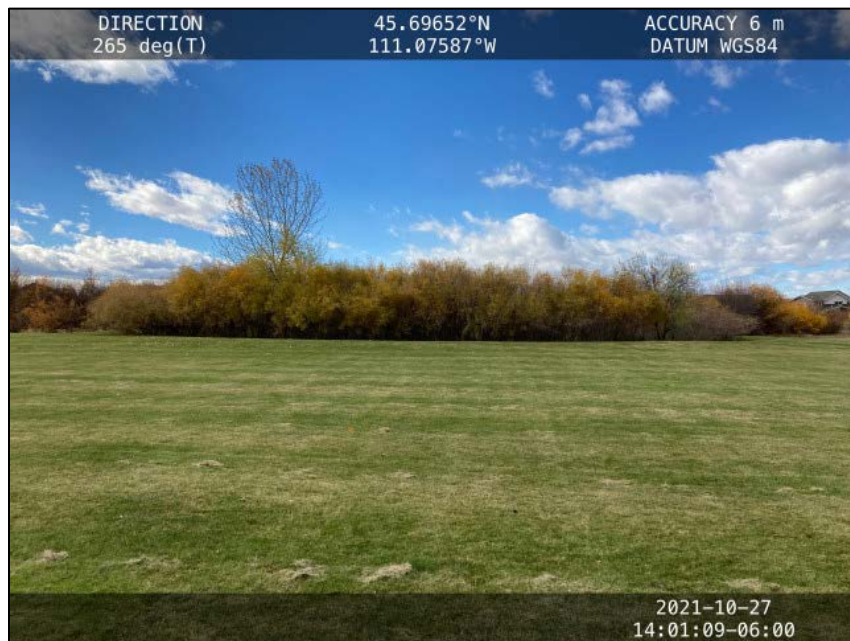
Image 1
Detention Facility 2A Overview – note abundance of willow

Findings and Recommended Actions: *The detention facility's inlets and outlets should be cleared to retain hydraulic function. Flowpaths should be free of obstructions and vegetation clearing will make future maintenance more practicable. Access agreement or permission from Parks Department is needed before machinery can be used in this facility.*

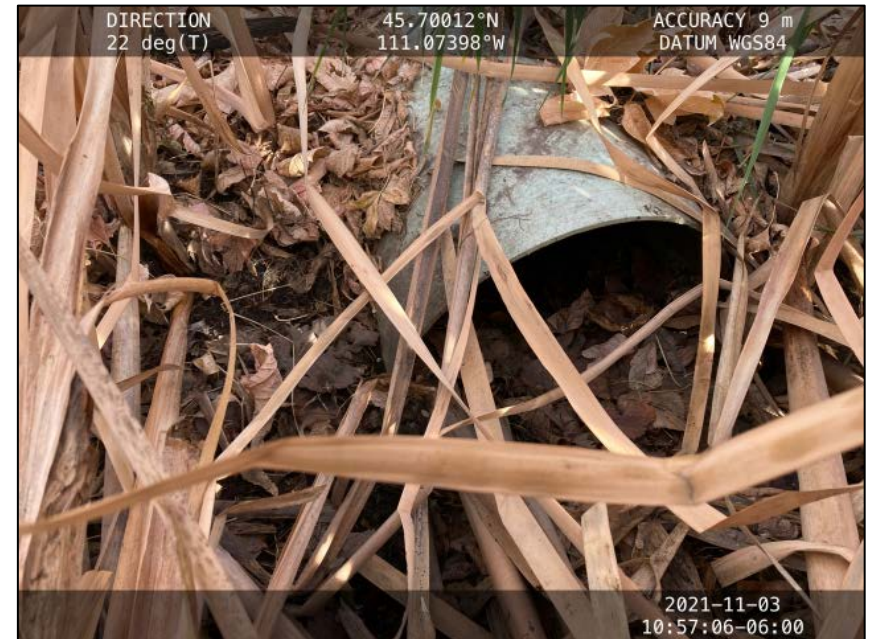
Findings and Recommended Actions: Significant overgrowth of cattails has constricted stormwater storage volume and there is a high risk of conveyance plugging at the pipe flowing in to the facility. Retention ponds do not have an active, piped outlet and wholly rely on infiltration. Sediment and excessive vegetation should be removed to improve infiltration.

Image 2
Retention Facility inlet from Baxter Ln; more than ½ filled with sediment

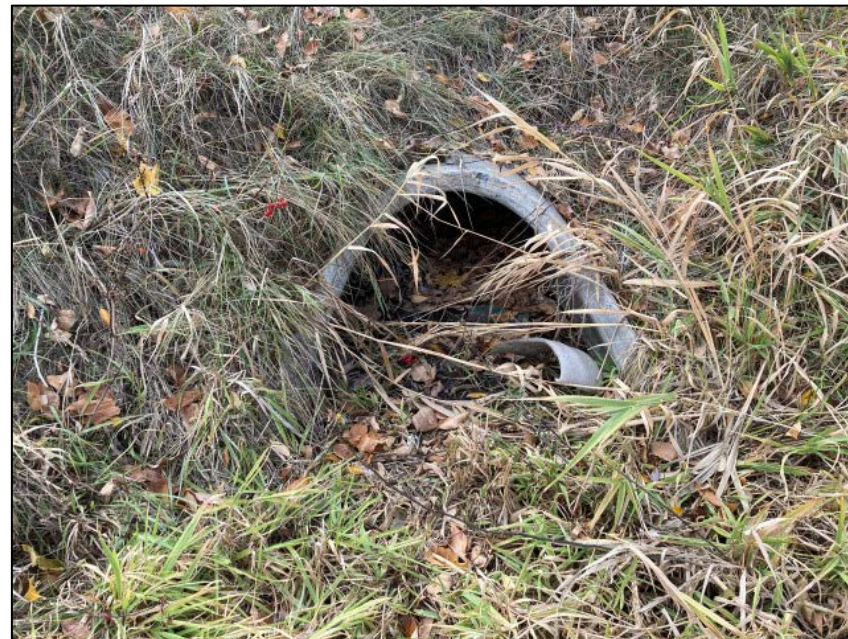
Image 2
Detention Facility Inlet showing sediment accumulation

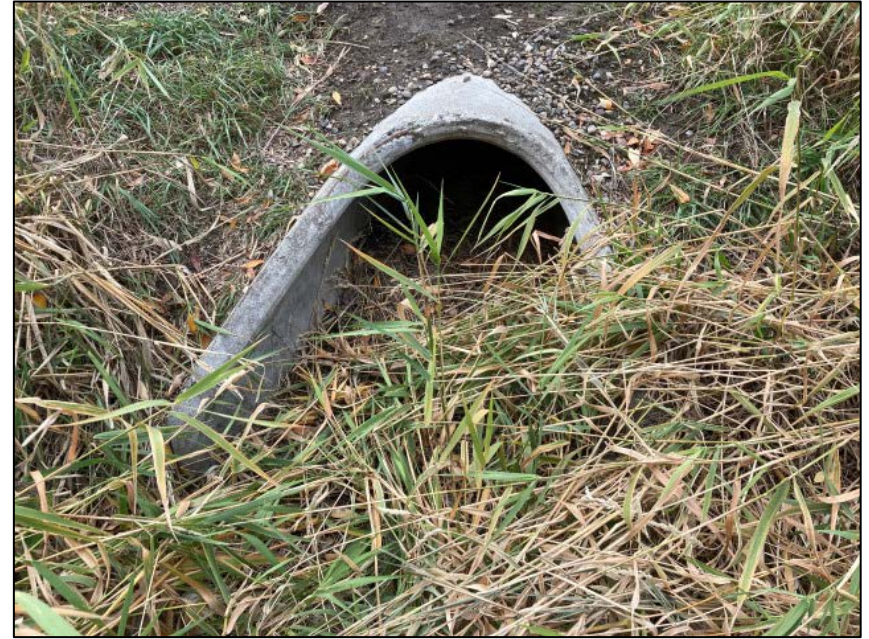
Image 4
Detention Facility Outfall with vegetation and sediment accumulation

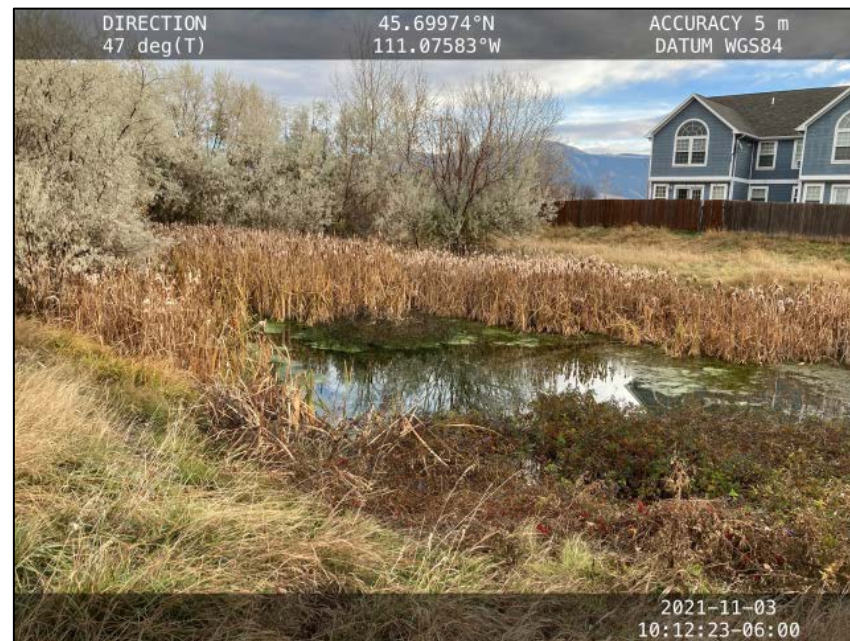
Image 2
Overview of detention facility looking northeast

Findings and Recommended Actions: This detention facility is overgrown with vegetation and has ponded and flowing water. Groundwater is following the outside of the pipe and entering the detention facility at the southern inlet. The base flow will limit maintenance options and function of this feature. Excess vegetation should be removed. Access agreement or permission from Parks Department is needed before machinery can be used in this facility.

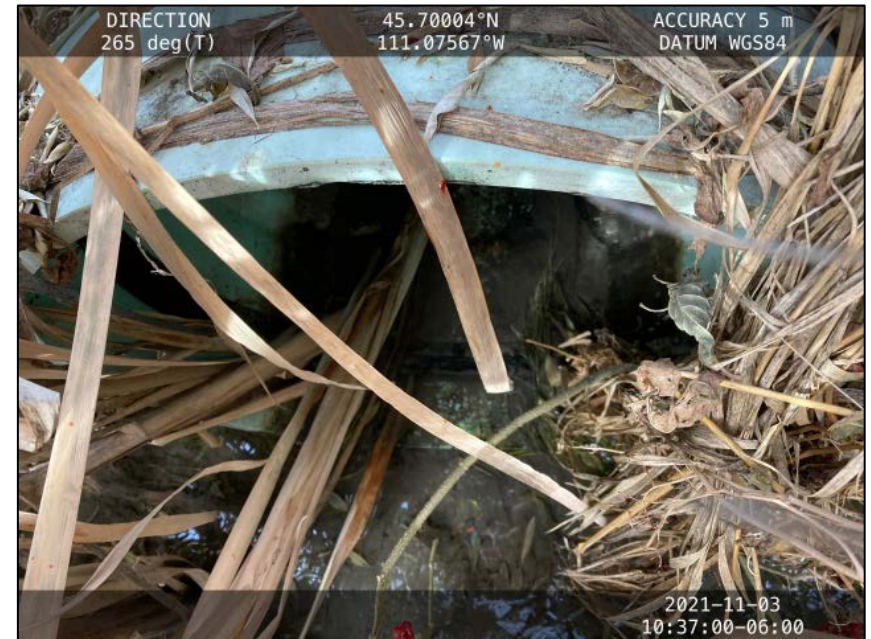
Image 4
Detention facility outlet; flowing water

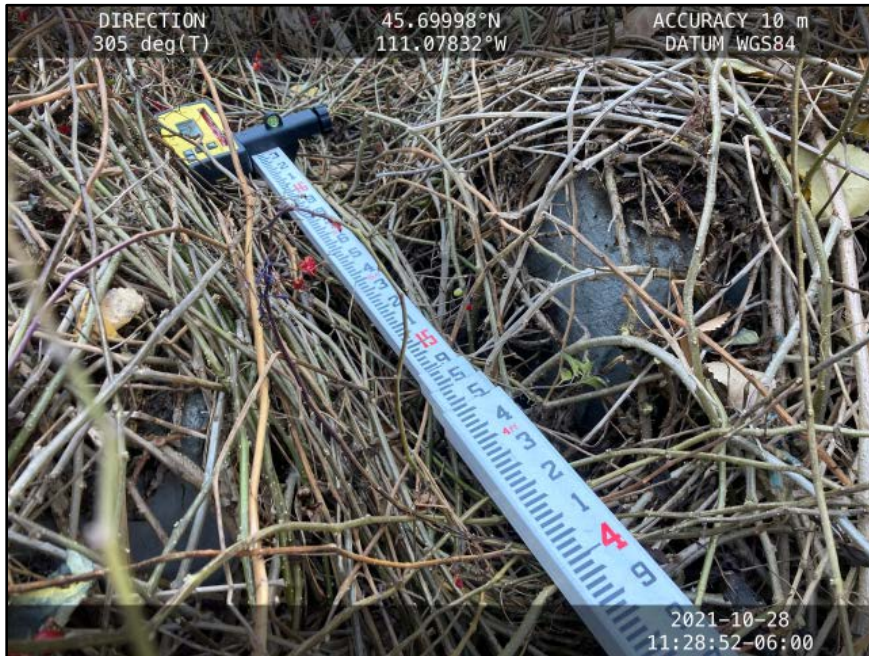
Image 3
Severe overgrowth at slotted concrete weir, near detention facility outlet

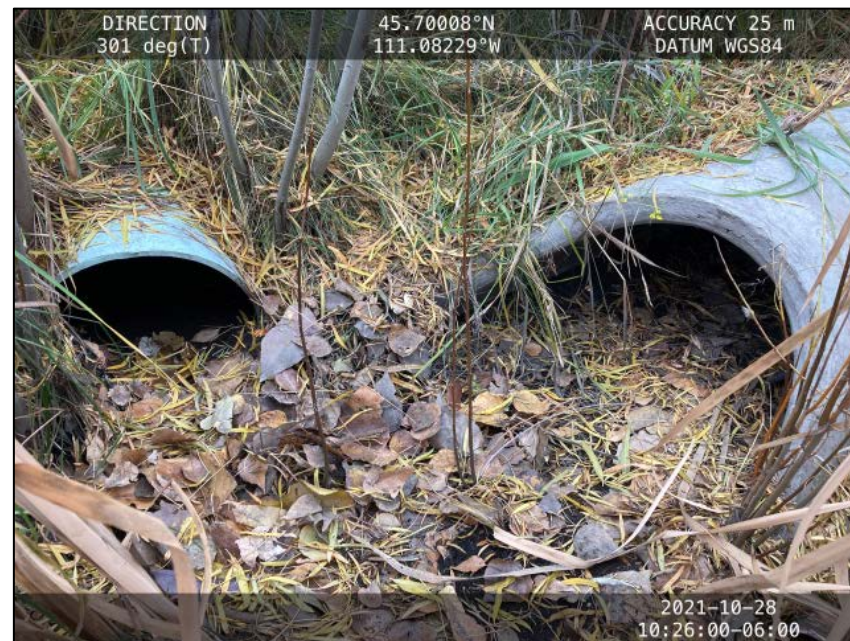
Image 2
Inlets at west end of detention facility, partially clogged with sediment

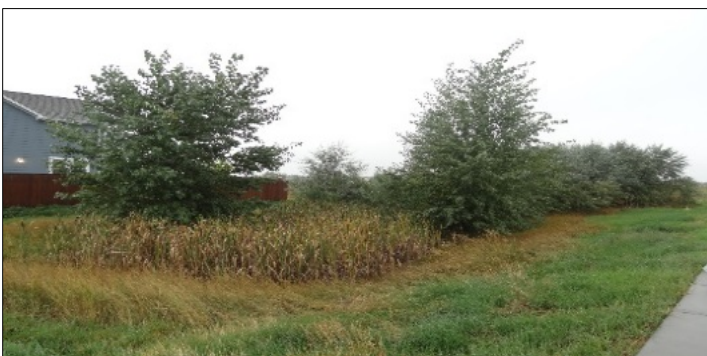
Image 2 - Overgrown vegetation

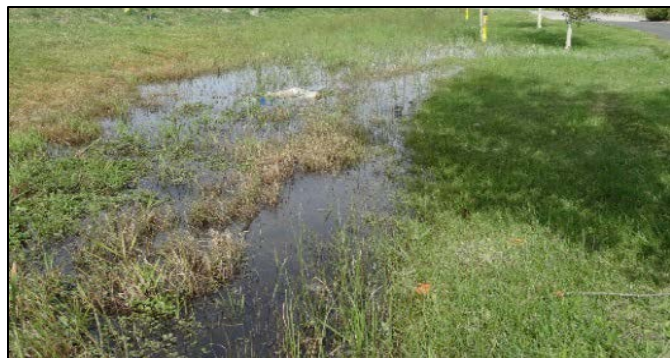
Image 5 - Water 3-days after rain event
