Subject: West Winds Stormwater Facility Management.
Date: Friday, July 28, 2023 at 1:46:51 PM Mountain Daylight Time
From: Russell Smith <rsmith@BOZEMAN.NET>
To: Debbie Chard <Debbie.Chard@westwindshoabozeman.org>, David Gianforte <David.Gianforte@westwindshoabozeman.org>, Kitch Walker <Kitch.Walker@westwindshoabozeman.org>
CC: Contact West Winds HOA <contact@westwindshoabozeman.org>
Attachments: Annual_Stormwater_Facility_SelfInspection_FillableForm.pdf, Stormwater Facility Maintenance Guide Sept2021.pdf, Pond Managment Guide EPA.pdf, West Winds Stormwater Inspection Report.pdf, West Winds Report CovLet.pdf, West Winds Stormwater Facilities Map.pdf, ATT00001.txt, ATT00002.htm

RE: West Winds HOA Stormwater Infrastructure Inspection

Stormwater Facilities Inspection Report

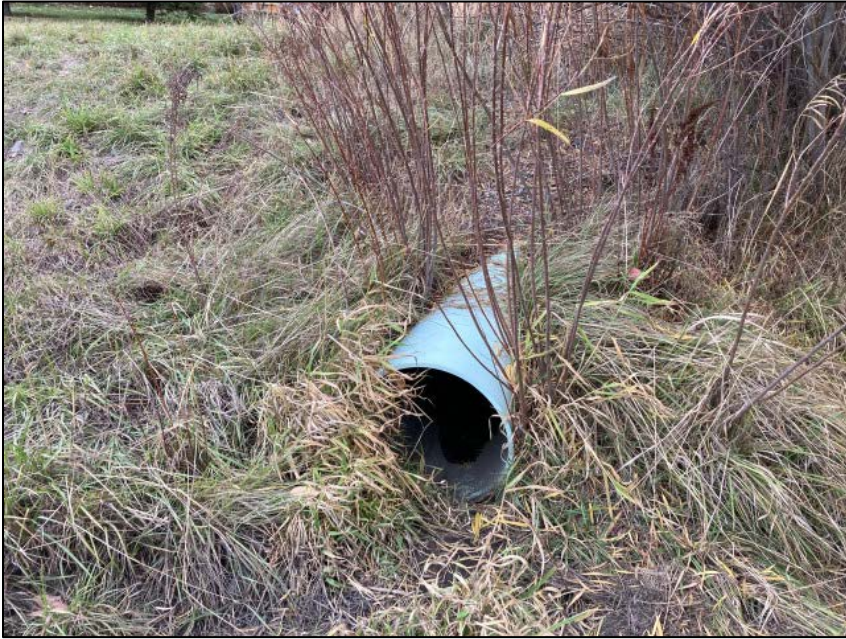
Image 3
Outlet pipe within detention facility showing willow growth
encroachment

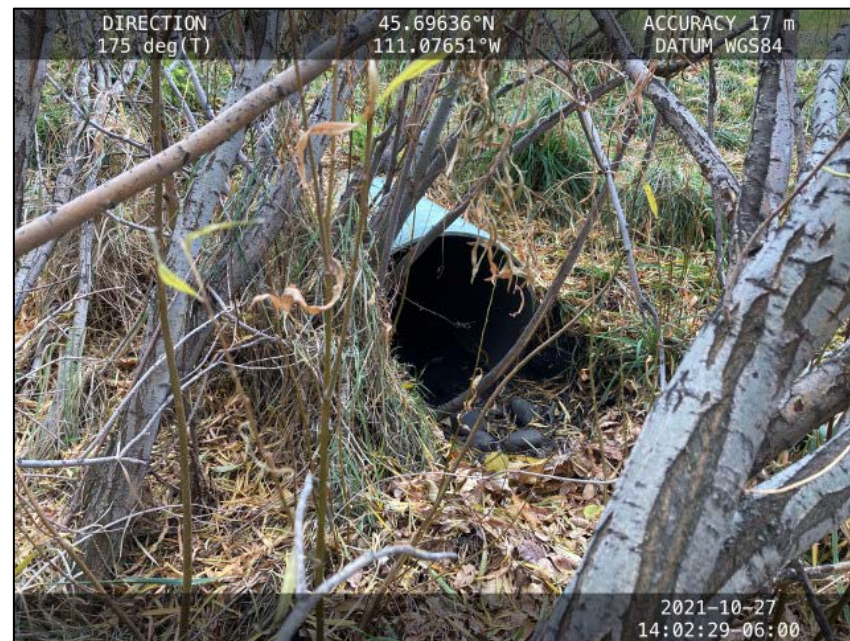
Image 2
Detention Facility Inlet

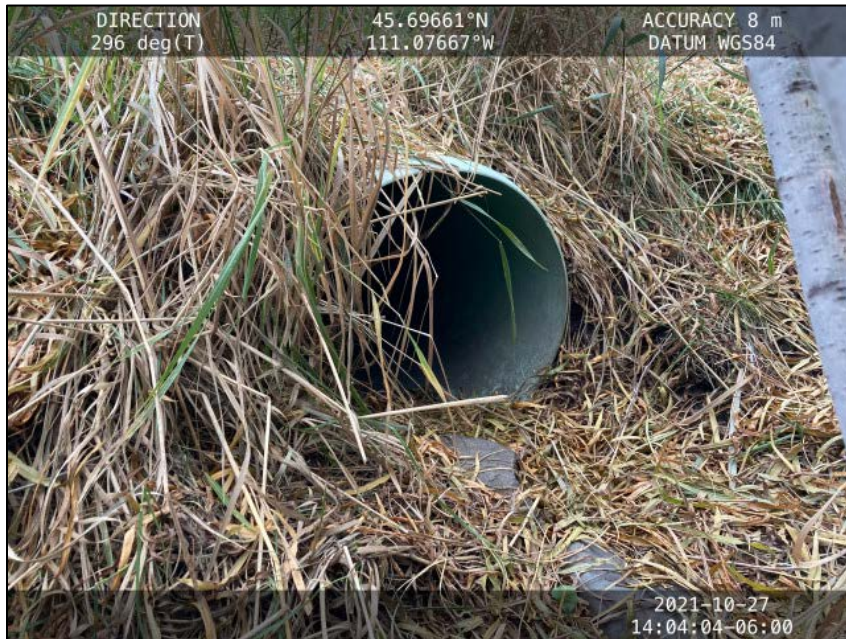
Image 3
Detention Facility Outlet

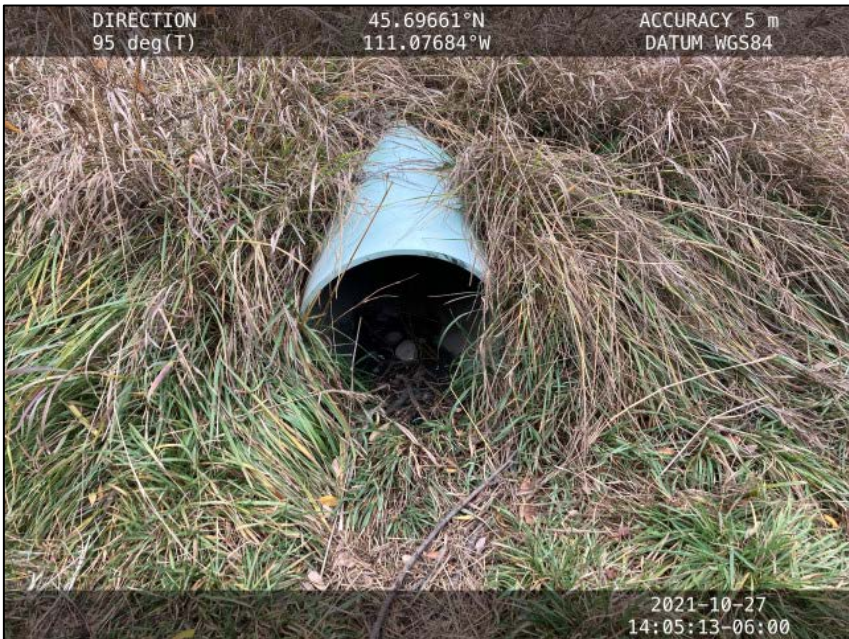
Image 4
Detention Facility Outfall

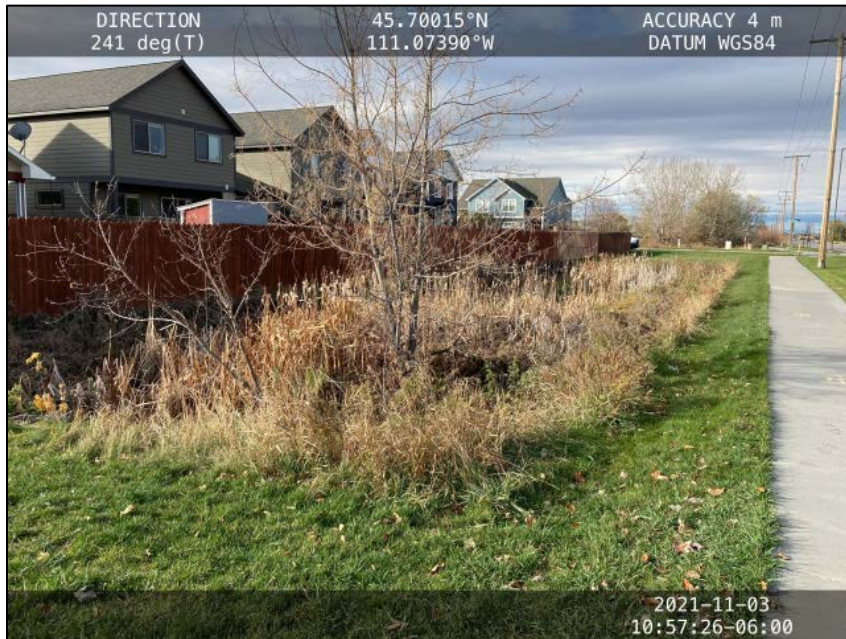
Findings and Recommended Actions: Significant overgrowth of cattails has constricted stormwater storage volume and there is a high risk of conveyance plugging at the pipe flowing in to the facility. Retention ponds do not have an active, piped outlet and wholly rely on infiltration. Sediment and excessive vegetation should be removed to improve infiltration.

Image 1
Retention Facility 2B overview looking west

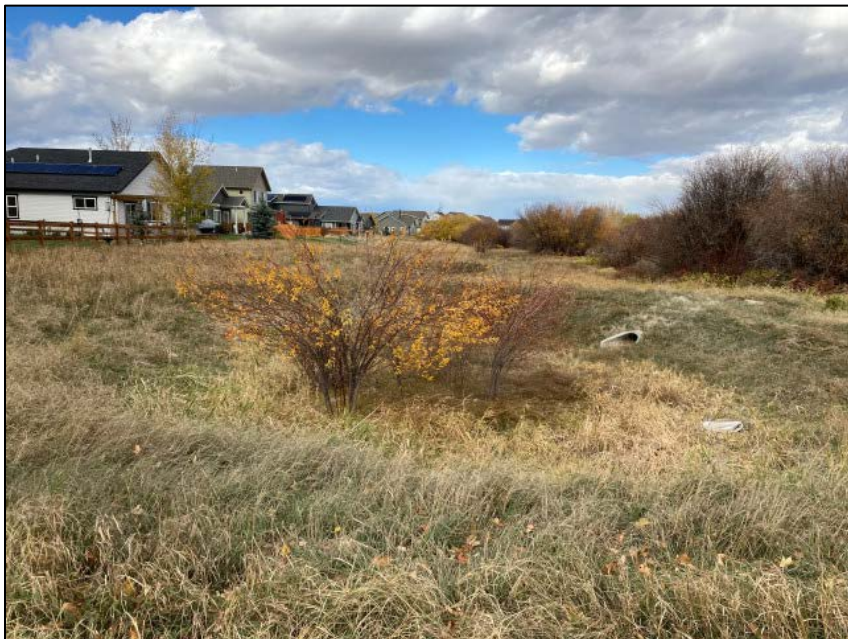
Image 1
Detention Facility 4.1 - Overview looking north

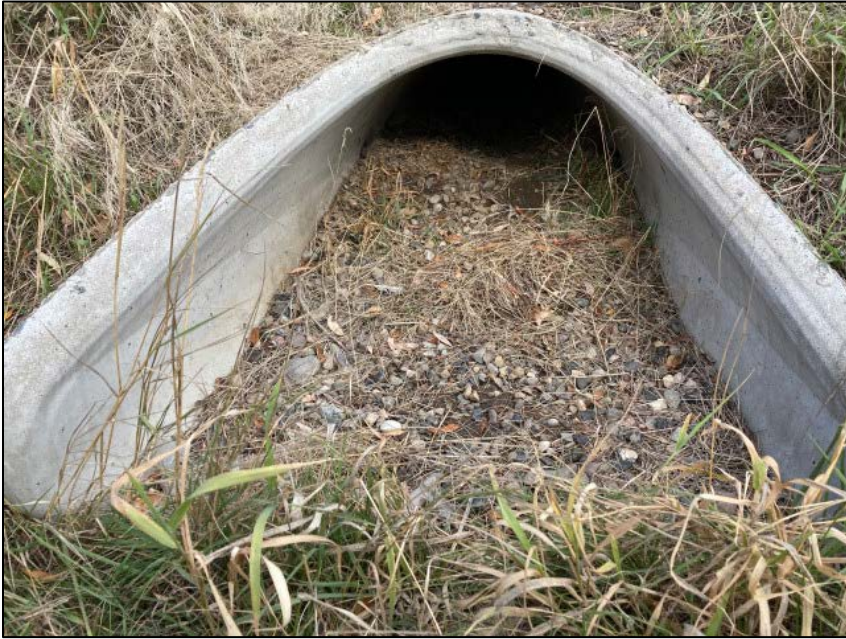
Image 3
Detention Facility Outlet showing sediment accumulation

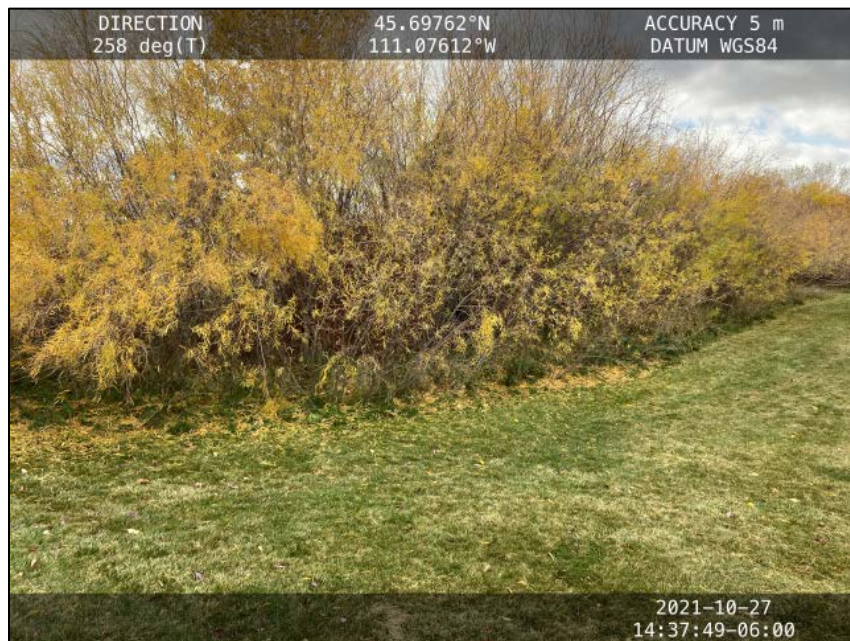
Image 1
Detention Facility 'forebay' closest to Tschache Rd inlet

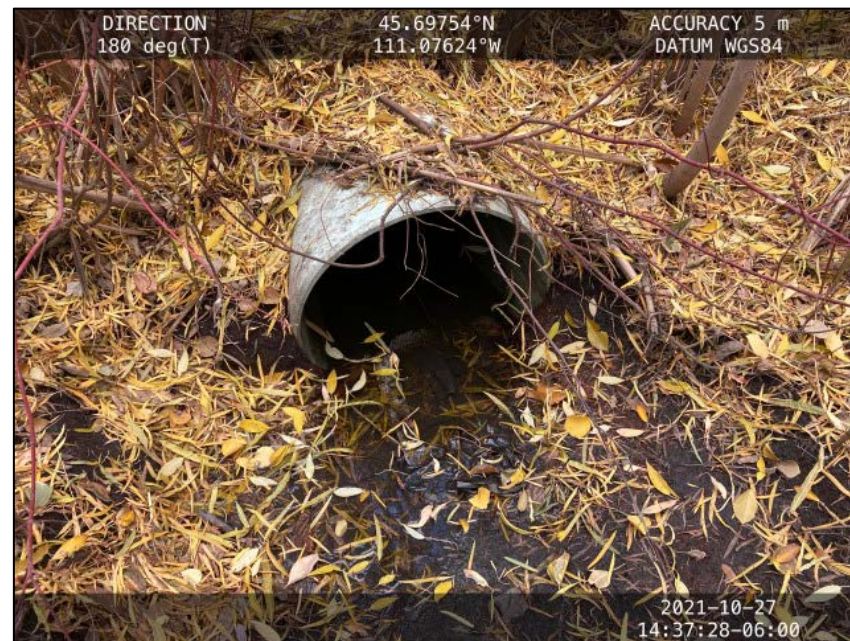
Image 2
Detention Facility Inlet from Tschache Rd to 'forebay'

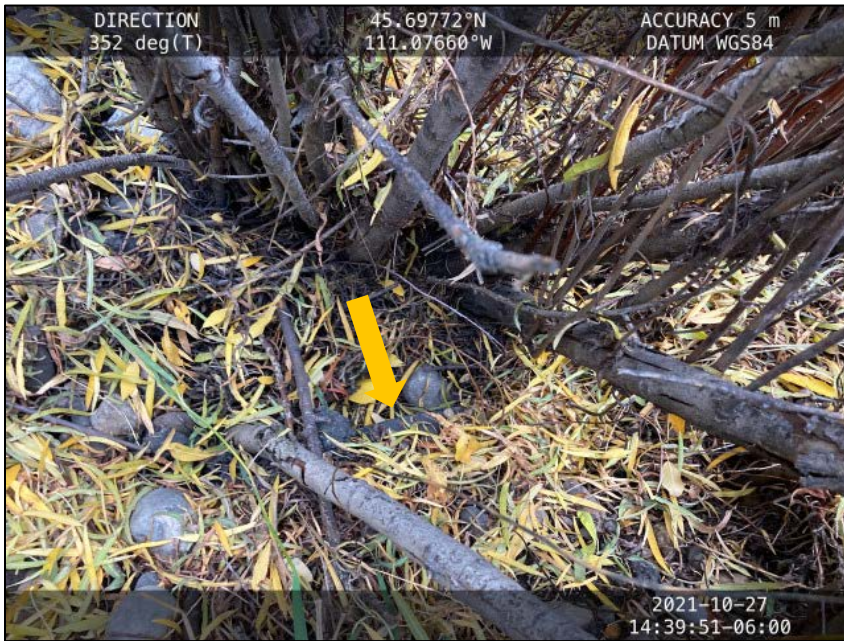
1.4	Infrastructure Condition	Damaged inlet pipe, outlet pipe, outfall structure, or fencing?	<input type="checkbox"/> Yes <input checked="" type="checkbox"/> No	
Facility Condition	2.1	Pretreatment Bay or Facility	Clogged, obstructed, or filled pretreatment forebay or facility?	<input checked="" type="checkbox"/> Yes <input type="checkbox"/> No	Inlet to facility open; culvert pipe along access road highly impacted by sediment and vegetation

Image 3
Facility culvert (down-gradient end), arrow pointing to culvert location

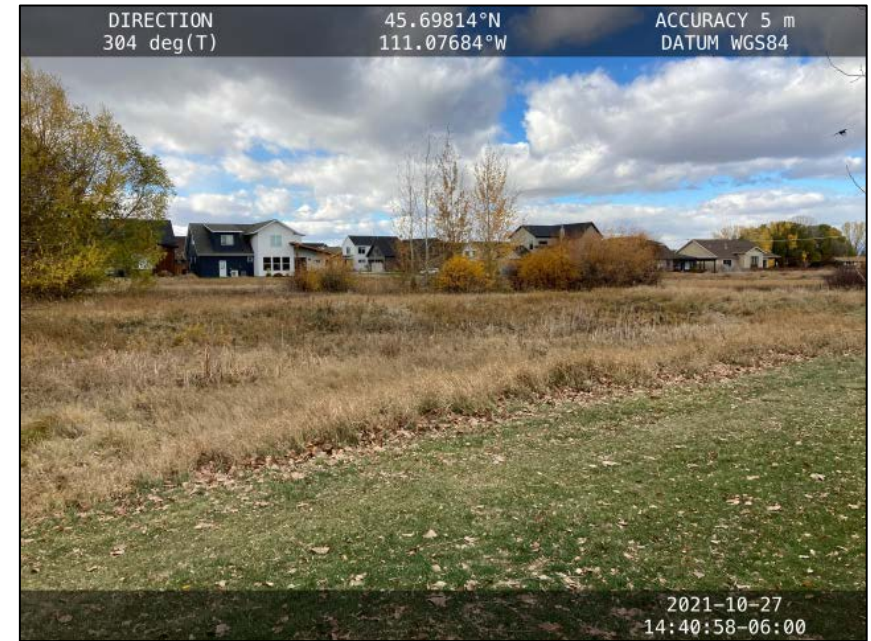
Image 4
Detention facility main bay, overview looking northwest

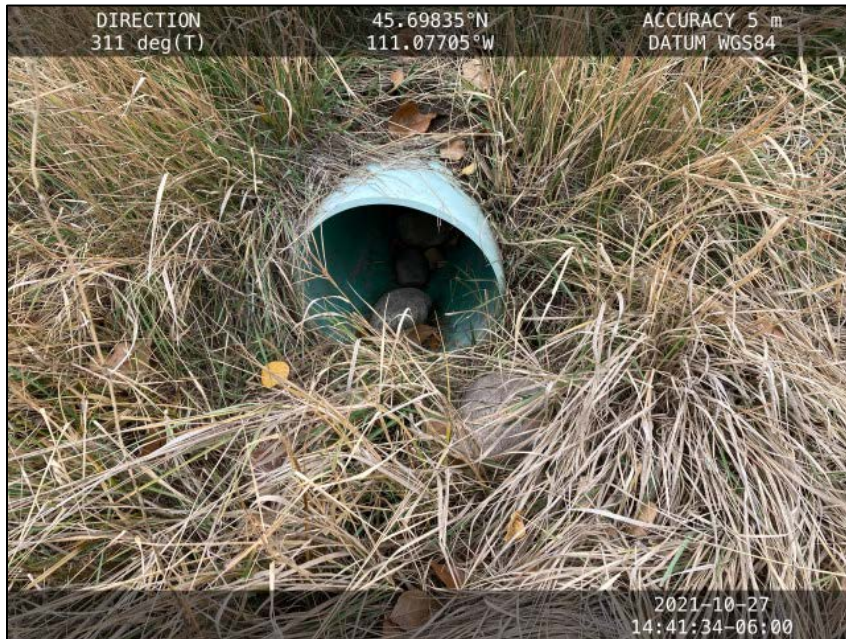
Image 5
Detention facility outlet

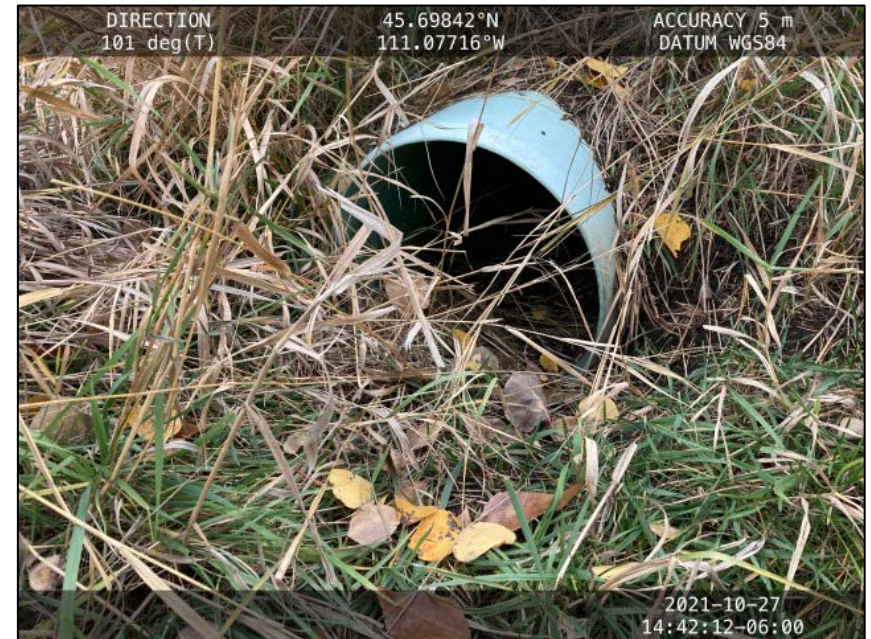
Image 6
Detention facility outfall

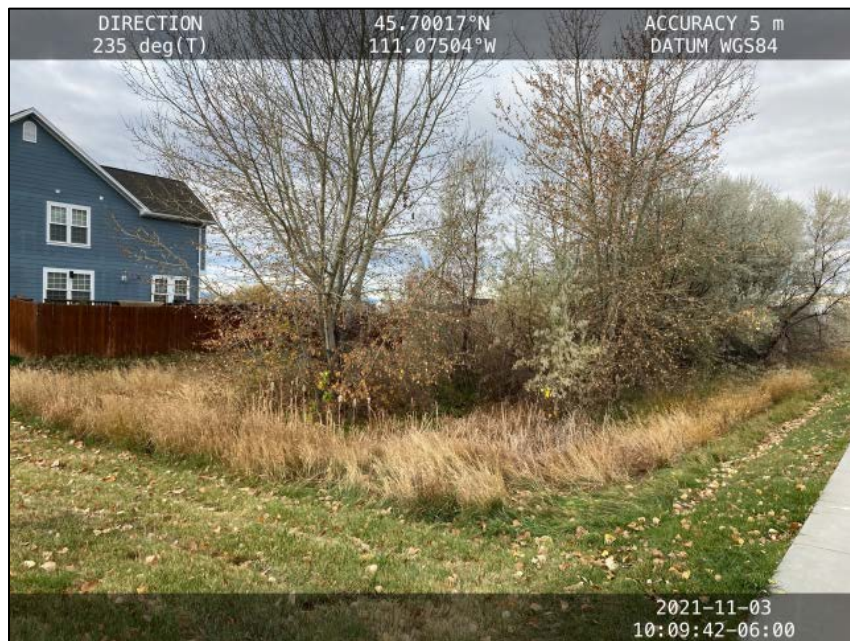
Image 1
Overview of detention facility looking west

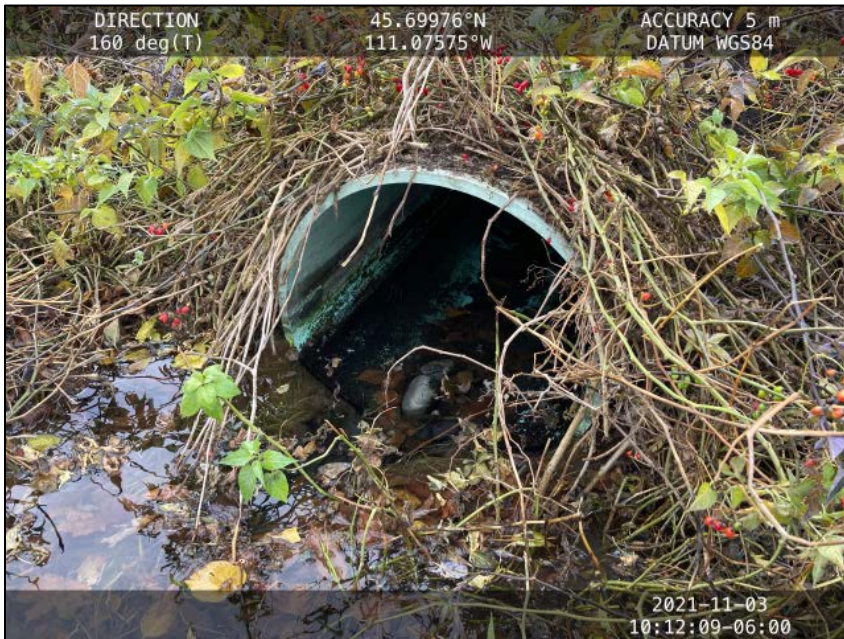
Image 3
Southern detention facility inlet, water flowing into basin from around and outside of pipe

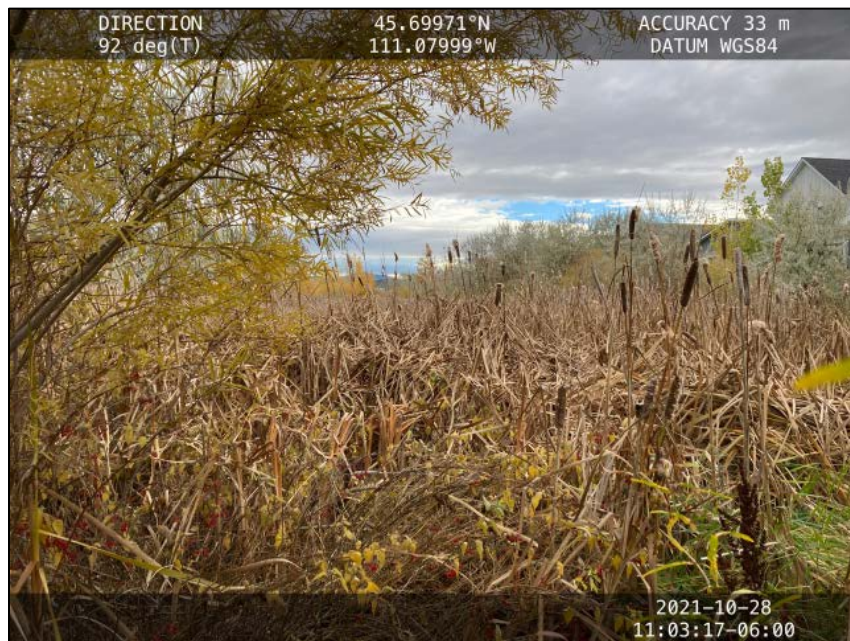
Image 1
View from interior of detention facility looking east

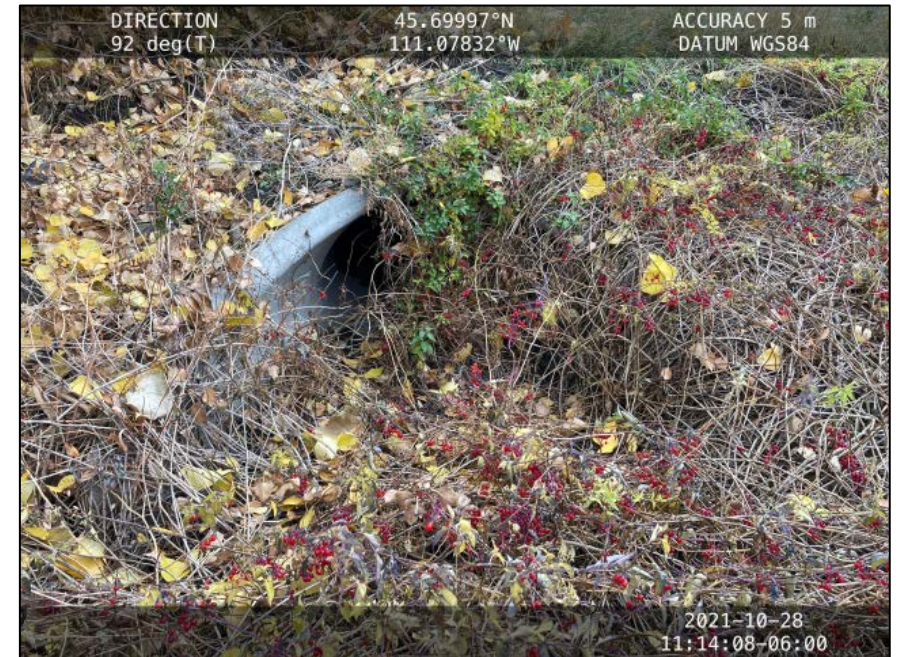
Image 4
Detention facility outflow FETS

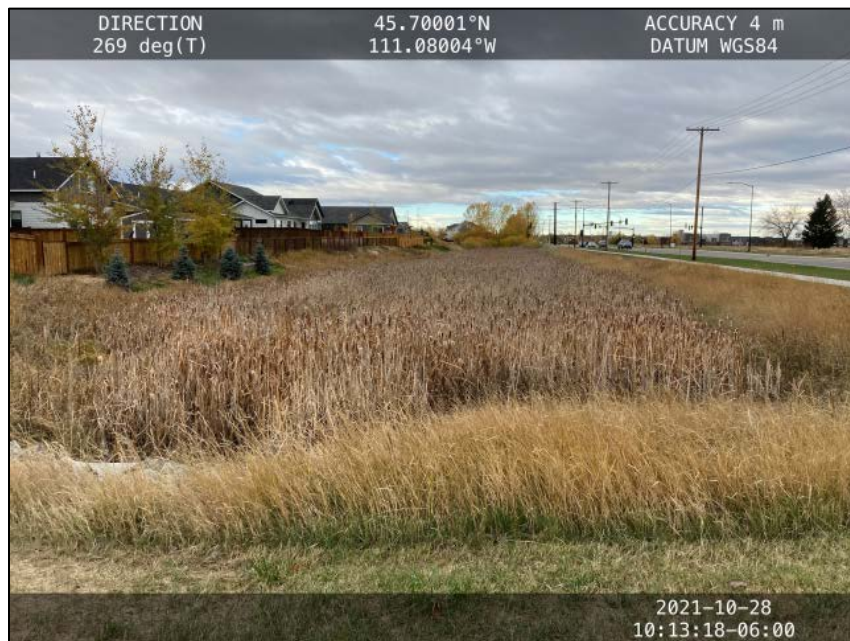
Image 1
Detention Facility 8, overview looking west

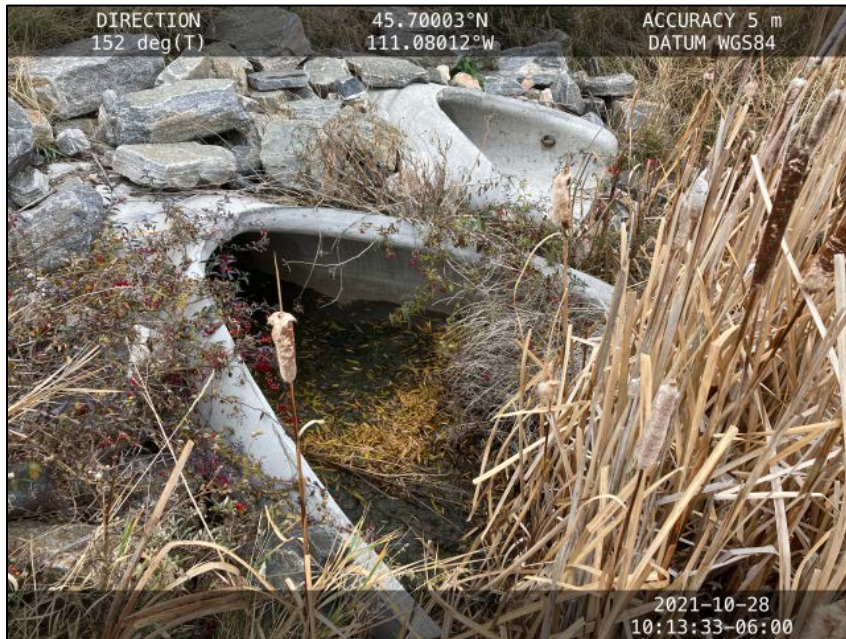
Image 3

Detention Facility outlet; inhibited flow and vegetation growth.
